Contract #: 04-0120F4Cty: SF/ALA Rte: 80 PM: 13.2/13.9File #: 1.28**WELDING INSPECTION REPORT****Resident Engineer:** Casey, William**Address:** 333 Burma Road**City:** Oakland, CA 94607**Report No:** WIR-027604**Date Inspected:** 15-May-2012**Project Name:** SAS Superstructure**OSM Arrival Time:** 700**Prime Contractor:** American Bridge/Fluor Enterprises, a JV**OSM Departure Time:** 1730**Contractor:** American Bridge/Fluor Enterprises, a JV**Location:** Job Site**CWI Name:** As noted below.**CWI Present:** Yes No**Inspected CWI report:** Yes No N/A**Rod Oven in Use:** Yes No N/A**Electrode to specification:** Yes No N/A**Weld Procedures Followed:** Yes No N/A**Qualified Welders:** Yes No N/A**Verified Joint Fit-up:** Yes No N/A**Approved Drawings:** Yes No N/A**Approved WPS:** Yes No N/A**Delayed / Cancelled:** Yes No N/A**Bridge No:** 34-0006**Component:** Tower Component**Summary of Items Observed:**

In Process Visual Inspection**Tower**

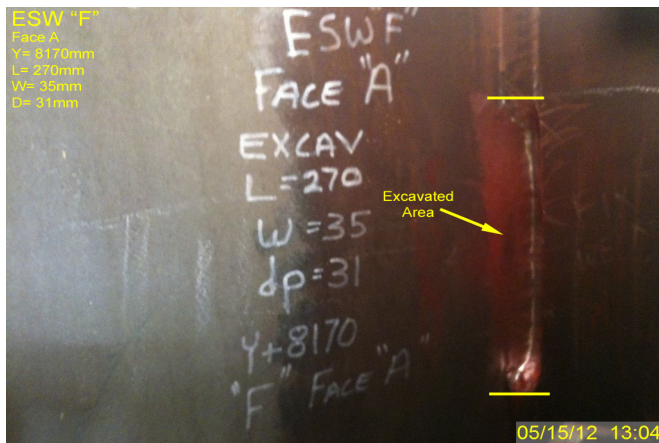
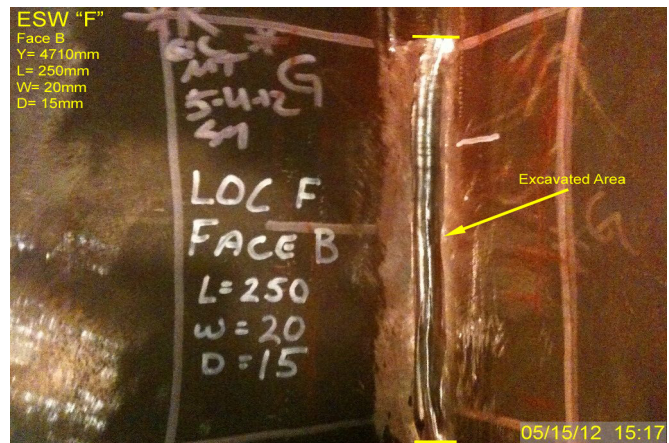
This QA observed, at random intervals, ABF/JV qualified welder Richard Garcia #5892 performing Shielded Metal Arc Welding (SMAW) with 3.2mm diameter E7018H4R electrode and implementing Caltrans approved Welding Procedure Specification (WPS) ABF-WPS-D15-1001-Repair. The joint being welded was tower shear plate designated as ESW weld, location "P" from face "A".

Dimensions excavated for this repair were: (Y=100mm, I=660mm, W=67mm, D=52mm)

This QA randomly observed ABF/JV welding personnel performing excavation of welds previously Ultrasonic Testing (UT) rejected. Quality Control (QC) Inspector John Pagliero performed Magnetic Particle (MT) and visual confirmation of excavations.

Weld "F" – Y=8170mm, L=270mm, W=35mm, D=31mm

Weld "F" – Y=4710mm, L=250mm, W=20mm, D=15mm

This QA Inspector performed Magnetic Particle Testing (MT) of weld repair excavations on two locations on tower ESW "F". This QA observed no rejectable indications at the time of testing. This QA Inspector generated a TL-6028 MT report on this date. The completed work observed at this location appeared to be in compliance with the contract specifications.

This QA Inspector performed Magnetic Particle Testing (MT) of approximately 15% of the root pass weld at "Weld #110". This root pass weld was previously accepted by QC Magnetic Particle technicians. This QA observed no rejectable indications at the time of testing. This QA Inspector generated a TL-6028 MT report on this date. The completed work observed at this location appeared to be in compliance with the contract specifications.
